Field and laboratory performance of bridge columns repaired with wrapped glass-fibre-reinforced-polymer sheets¹

Shamim A. Sheikh

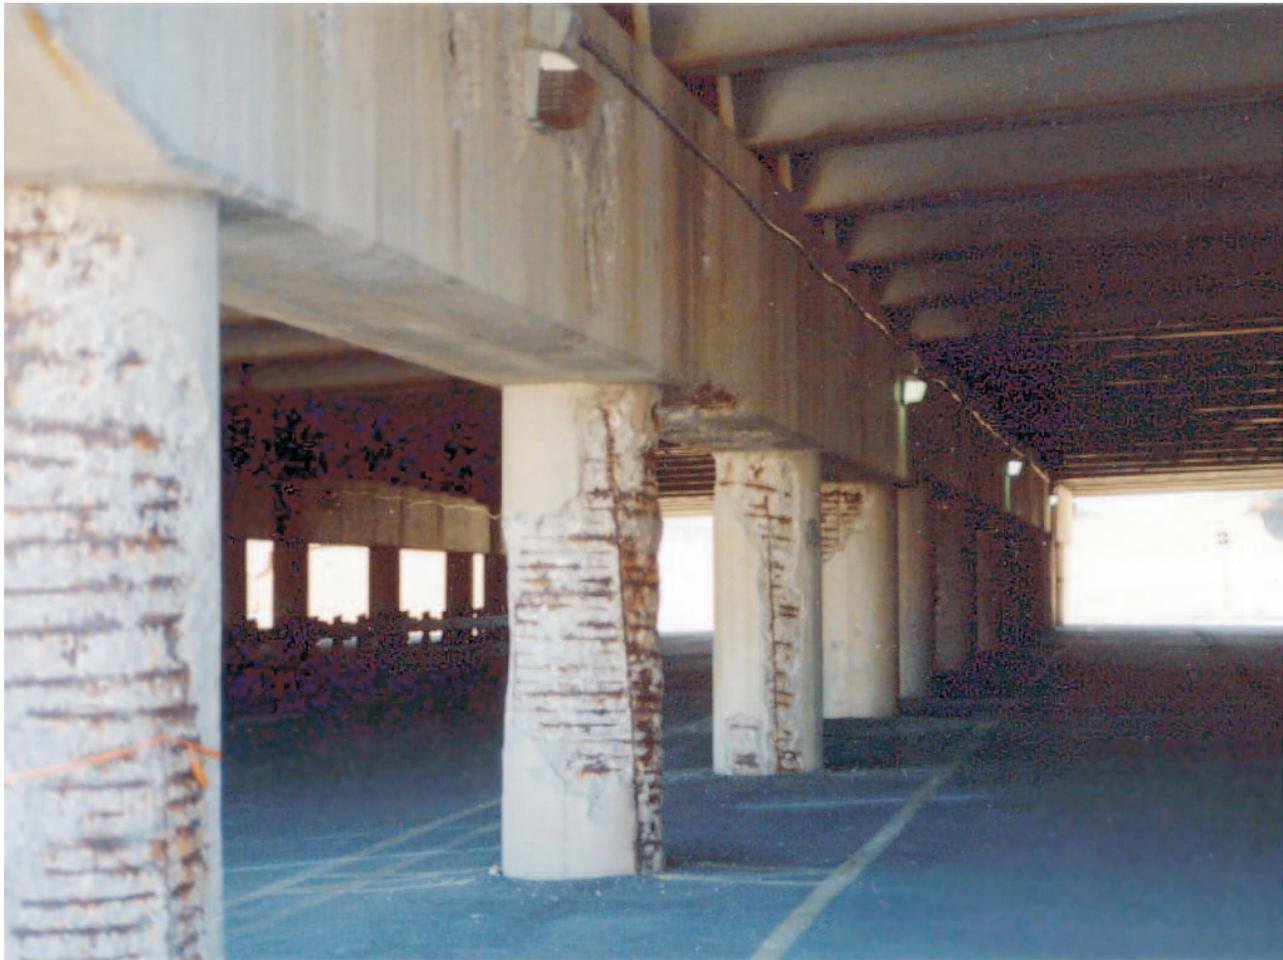
icing salt. The bridge is in Toronto, on Highway 401, and was built in the 1960s, using concrete with a specified strength of 20.7 MPa. The highway has seven westbound and six eastbound lanes at this location. Figure 1 shows several damaged columns on the westbound part of the bridge. The columns are 920–1010 mm in diameter.

The damage seen in Fig. 1 is concentrated at the bents that are directly below the expansion joints. Over time, the joint sealant and other materials deteriorated as a result of extreme weather conditions and chemicals from de-icing salts, allowing the water–ice–salt solution to pass through the joints to the reinforced concrete bents. Accumulation of this solution at the bent top and its continuous flow downward resulted in deterioration of the concrete, as well as in corrosion of the steel. The columns may also have been subjected to splashes of salt solution from cars using the area under the bridge as a parking lot. In addition to the direct chemical attack, the structure was subjected to the usual environmental effects of freeze–thaw cycles, ultraviolet exposure, water, wet–dry cycles, etc. As a result, the spiral steel in the columns and the tie steel in the beams were severely corroded, which led to severe delamination of the cover concrete in both the columns and the girders. However, little corrosion was observed in the longitudinal bars.

Fig. 1. Damaged highway bridge.

Repair of field columns (see Fig. 1) was designed on the basis of the tests briefly described above. The concrete cover had spalled off, and spiral steel had corroded extensively in

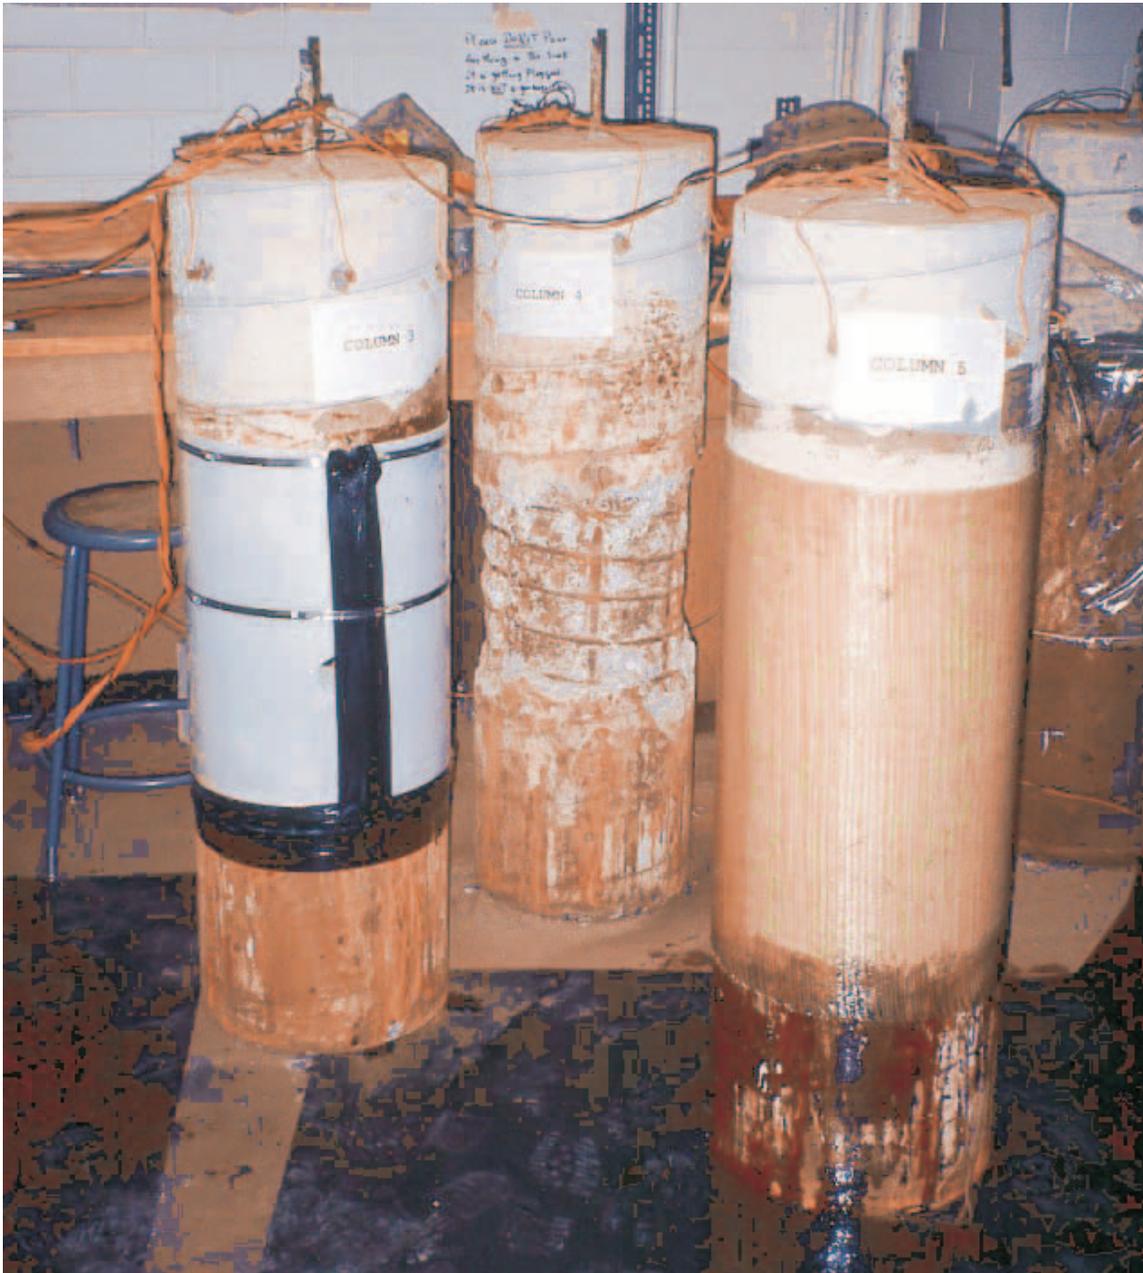
repaired and were used as control specimens, along with two uncorroded columns. Figure 3 shows a column with simulated damage and two columns in different stages of repair. The results from short-term tests on four columns are presented in Fig. 4. The repair work was carried out with the aim of minimizing the costly fieldwork. It was decided, in consultation with the Ministry of Transportation of Ontario (MTO), that the corroded steel and the contaminated concrete would not be removed from the damaged columns. It was also decided to investigate the use of a plastic sheet, wrapped around the column as formwork for grout and as a barrier between the new grout and the GFRP. The barrier was considered necessary because, on the basis of simulated lab studies in which fibres alone were immersed in sodium hydroxide solution, researchers (e.g., Uomoto and Nishimura 1999) had reported that alkalis reacted adversely with glass fibres.

Fig. 3. Damaged columns in the laboratory.

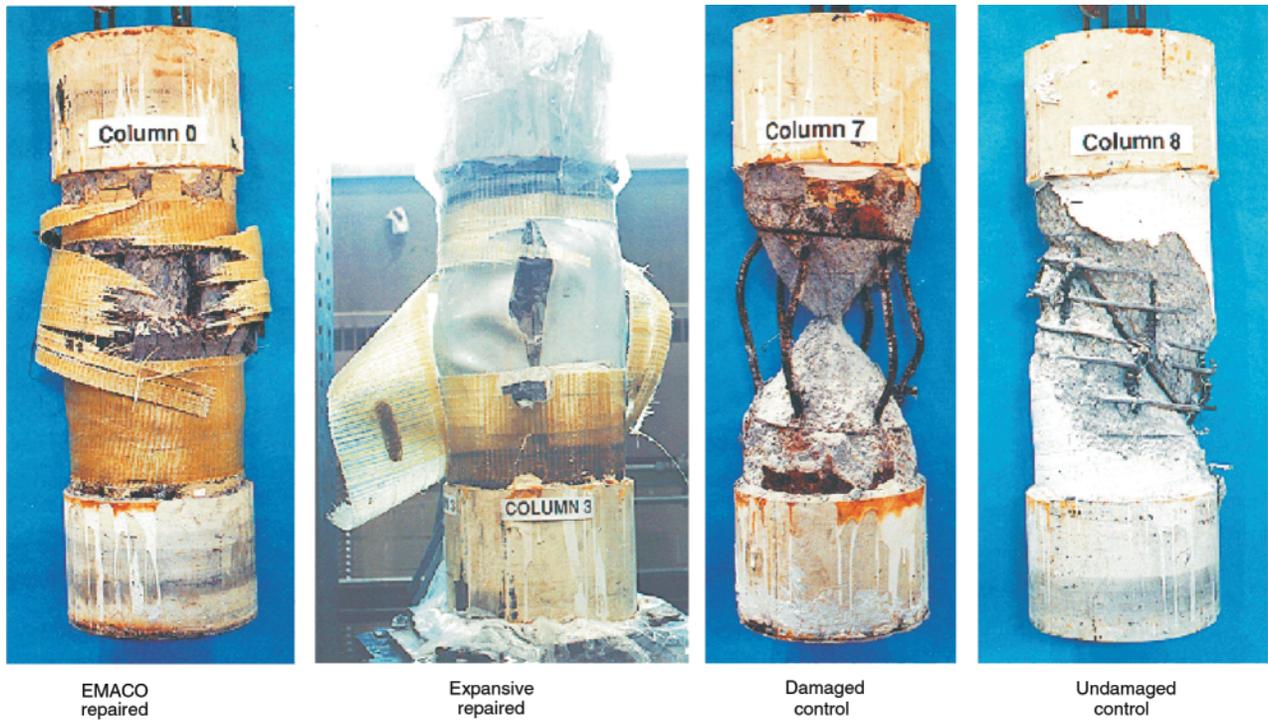
sheet of the formwork opened out and engaged the fibre wrap, creating large local strain and premature failure of the wrap and hence the column. Figure 5 clearly shows the opening of the formwork sheet in the Exp-repaired column and its adverse effects on the FRP compared with the Emaco-repaired column.

Fig. 5. Columns after testing.

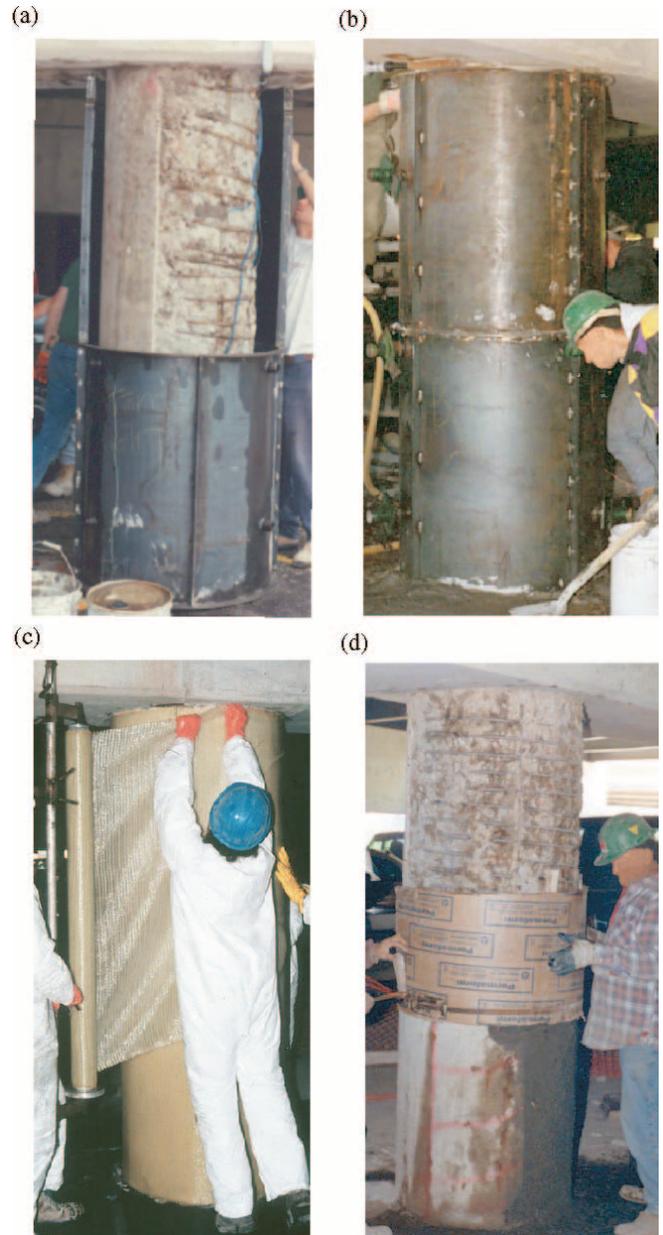
Fig. 9. Various steps in column repair: (a) steel formwork being placed around column; (b) steel formwork wrapped around column; (c) column wrapped with a polyethylene sheet and two layers of glass-fibre-reinforced-polymer fabric; (d) column rebuilt to its original shape with an Emaco-based mortar.

Column 124-1 was repaired with expansive concrete grout and steel formwork (Figs. 9a and 9b). The grout, which replaced the original cover concrete, was about 50 mm thick and had the following mix proportions by weight: 306 kg normal Portland cement, 128 kg H-HAC, 61 kg moulding plaster, 15 kg hydrated lime, 742 kg sand, 902 kg 6 mm crushed rock, 217 kg water, and superplasticizer. Approximately 20 h after grouting, the formwork was removed, and the column was wrapped with a 0.15 mm thick polyethylene sheet and then two layers of GFRP in which the fibres were aligned in the circumferential direction to confine the column (Fig. 9c). The polyethylene sheet acted as a barrier between the new concrete and the GFRP and would not affect the column behaviour under load. Three days after the grout application, six strain gauges were installed in the circumferential direction on the GFRP wrapped around the column.

Column 124-3 was built to its original shape with Emaco-based mortar. No formwork was needed for this rheoplastic mortar (Fig 9d). A protective epoxy coating was applied 6 d later, followed by FRP wrapping and instrumentation similar to those of column 124-1. The gauges were applied to this column 8 d after grout application.

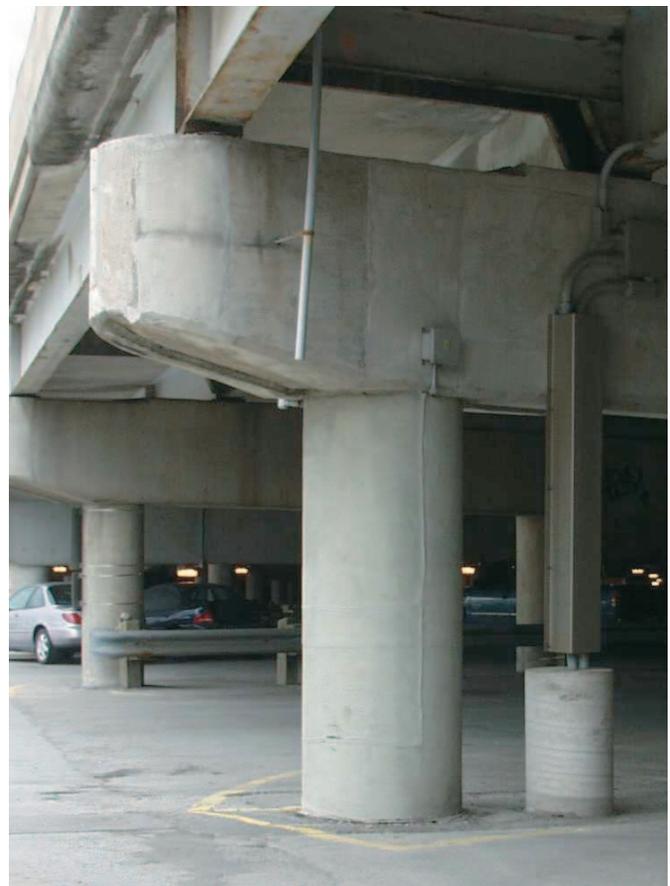
Visual inspection of the columns over 10 years and an examination of the field data on strain and corrosion indicate sound performance of the retrofit techniques. No distress or deterioration was observed in these columns after ten years of service, as shown in Fig. 14, and the risk of future corrosion appears to have been reduced. There has also been no need to repeat the repair process on any of the bridge columns repaired more than 10 years ago. In the repair of the columns in the mid-1990s a thin polyethylene sheet was used as a barrier between the new mortar or concrete and the GFRP to avoid any possible adverse effects of alkalis on the performance of GFRP in the long term. Since then, however, extensive testing has shown excellent long-term performance of GFRP sheets under alkaline environments (Steckel et al. 1999; Homam et al. 2000, 2001; Mufti et al. 2005). Future repairs using GFRP can thus be carried out without the use of barriers. Although the presence of the barrier is not necessary for isolating glass from alkali, the barrier might have been partially responsible for the reduced corrosion activity in the columns.

Fig. 14. Repaired columns after 10 years of service.
