Field and laboratory performance of bridge columns repaired with wrapped glass-fibre-reinforced-polymer sheets¹

Shamim A. Sheikh

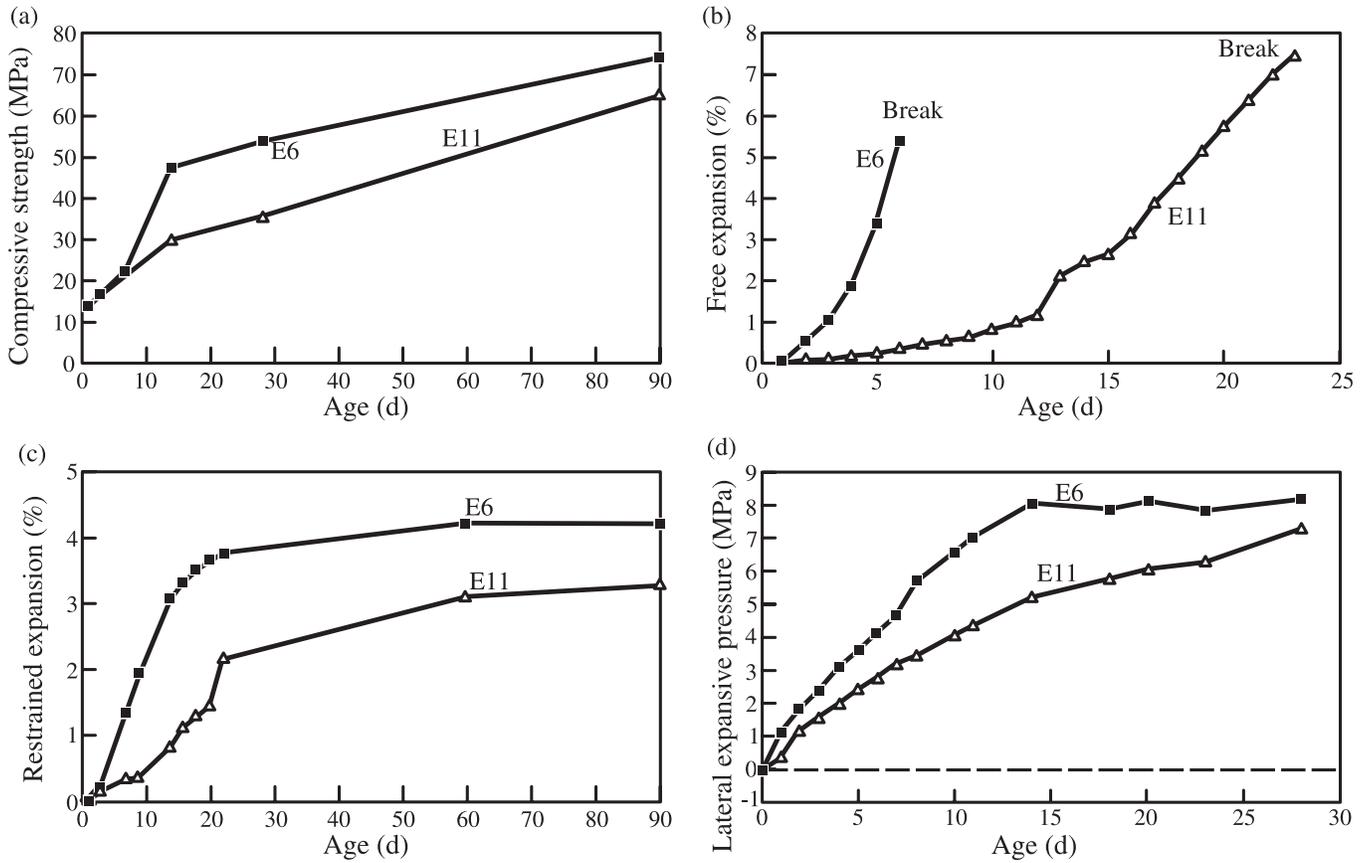
Fig. 2. Properties of expansive concrete. Note: E6, high-alumina cement sample; E11, hydrated high-alumina cement sample.

Using H-HAC in place of HAC in the formulation of expansive cement improved the set properties to the desired levels: expansive cement with HAC does not provide enough time before setting for most uses in the field, whereas expansive cement with H-HAC displayed early age behaviour that was suitable for field applications. Figure 2 compares various properties of two expansive concrete samples, E6 and E11 (Sheikh et al. 1994). The only difference between the two samples is that E6 contained HAC and E11 contained H-HAC. The mix proportions are given in Table 1. A small amount of superplasticizer was used in the concrete to improve its workability considerably without adversely affecting the expansion properties. An initial slump of approximately 160 mm was maintained for about 30 min in E11, and at 60 min the slump was still approximately 100 mm.

The concrete strength (Fig. 2a) was measured from tests on unconfined 100 mm \times 200 mm cylindrical specimens that were cast in steel tubes with 6 mm wall thickness. The specimens in the steel tubes were cured in water under triaxially restrained conditions: the lateral restraint was provided by the tube wall, and the longitudinal restraint was provided by steel plates at the ends, connected with three threaded rods having a diameter of 8 mm. The specimens were squeezed out of the tubes at the time of testing. The free longitudinal expansion values shown in Fig. 2b were measured on specimens that were cured in water at 23 °C after demoulding at the age of 24 h. Extensive cracking in the specimens indicated that the total free expansion measurements did not necessarily represent the true values. The restrained expansion data shown in Fig. 2c represent the longitudinal expansion of 100 mm \times 200 mm cylinders cast in polyvinyl chloride tubes with 3 mm wall thickness. After 24 h of moist curing, the specimens were cured in water at 23 °C until the end of the tests. Lateral restraint was provided by the tube walls throughout the test. The lateral expansion pressure results (Fig. 2d) were obtained from specimens that were cast in 150 mm diameter \times 300 mm steel tubes with 3 mm wall thickness. The longitudinal restraint was again provided by steel plates at the ends that were connected with three 8 mm diameter all-threaded bars. Lateral pressures were determined from strain measurements on the surface of the steel tubes.

In addition to delaying the set time, it is clearly demonstrated that the use of H-HAC in place of HAC delays the expansion of concrete so that the expansion develops as the concrete hardens and gains strength. The ultimate values of expansion, expansion stress, and compressive strength for the two types of concrete were found to be reasonably similar (Fig. 2).

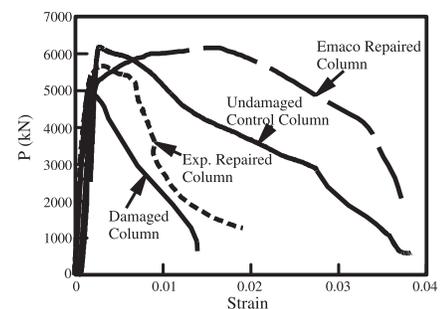
Fig. 4. Behaviour of columns under axial load (P). Note: exp., expansive cement mortar.

The damaged column had approximately 20% lower strength than the undamaged control column, because of the corrosion of steel and the loss of concrete cover (Fig. 4). The reduction in ductility and in energy-dissipating capacity was even higher. The cover concrete had almost entirely spalled off or become ineffective in the corroded columns (see Fig. 3). Figure 5 shows four columns at the end of their tests. It can be seen from the figure that corrosion rendered the spiral steel completely ineffective in the damaged columns. Pitting corrosion created weak locations along the spiral that ruptured at fairly small axial strains. The confinement that is needed at large strains is thus not available in corroded columns.

Both repair methods improved the behaviour of specimens compared with that of the damaged, unrepaired specimen. The axial-load-carrying capacity of the Emaco-repaired specimen was as large as that of the undamaged control column. Its ductility and energy-dissipating capacity were substantially higher than those of the undamaged control column, and its ductility properties also exceeded those of the undamaged control column. The Exp-repaired column, for which plastic sheet formwork was used, did not display as good a performance as the Emaco-repaired column for which no formwork was used. At larger strains, the plastic

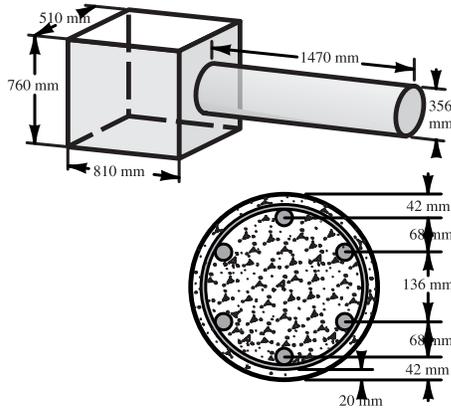
Fig. 6. Details of specimen tested under combined loads.

With the beneficial effects of FRP retrofitting observed for columns under concentric load in the first series of tests, the specimens for the second series were designed for evaluation under combined loads (Sheikh and Yau 2002). Twelve columns were tested under cyclic flexural and shear loads while simultaneously being subjected to constant axial loads. All the columns were 356 mm in diameter and 1.47 m long and cast integrally with a stub of dimensions 510 mm × 760 mm × 810 mm (Fig. 6). The column portion of the specimen represented the part of a column in a bridge between the section of maximum moment and the point of contraflexure. The stub represented the discontinuity that is similar to a footing or a beam-column connection. All columns contained six No. 25M longitudinal bars uniformly distributed around the core and had clear concrete cover that was 20 mm thick. The spiral consisted of U.S. No. 3 bars. Figure 7 shows an idealization of the test specimens. Figure 8 shows the moment-curvature behaviour of the critical sections in three column specimens designated by S-2NT, S-4NT, and ST-5NT (Table 2). All the columns were tested under an axial load of $0.27P_o$, where P_o represents the theoretical axial-load-carrying capacity of the column (CSA 2004). Specimen S-2NT contained spiral steel at 75 mm spacing, thus representing a column that is healthy and designed in accordance with the codes. Specimen S-4NT contained spiral steel at 300 mm spacing that represented a column in which spiral steel was lost because of corrosion or because the column was built with a deficiency. The response of column S-4NT, with sound concrete cover, would overestimate the response of a column that is damaged by corrosion and has lost the concrete cover. Column ST-5NT contained spiral steel at 300 mm spacing and was retrofitted with one layer of GFRP wrap. This specimen thus represented a repaired column in which the spiral steel was not replaced after being damaged. A comparison of the moment-curvature responses of specimens S-2NT and S-4NT underlines the importance of the spiral steel and its spacing on the behaviour of columns. Strength, ductility, energy-dissipating capacity, and the number of cycles of inelastic excursions that a column can sustain depend on the effectiveness of the spiral steel and the confinement it provides. The deficiency of the column as a result of the reduced spiral steel can easily be overcome by the addition of only one layer of GFRP wrap, as shown by the response of specimen ST-5NT. The strength, ductility, and energy-dissipating capacity of GFRP-retrofitted column ST-5NT are similar to or superior to those of control column S-2NT, which meets the current code provisions.

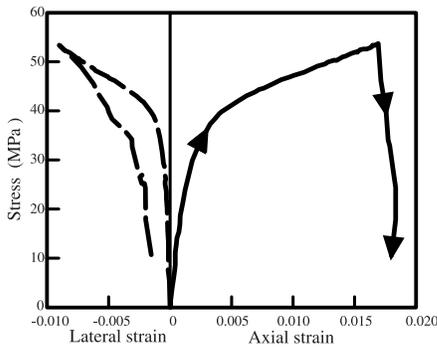
Fig. 10. Behaviour of expansive concrete confined with glass-fibre-reinforced polymer.

The compressive strength of wrapped expansive concrete cylinders varied from 44 MPa at 8 d to 50 MPa at 93 d. Some cylinders showed strength as high as 61 MPa. Axial stress – axial strain and axial stress – lateral strain curves for an FRP-confined expansive concrete cylinder at the age of 93 d are shown in Fig. 10. The cylinder failed by rupture of the FRP

wrap at an axial strain of approximately 0.017 when the cylinder was still showing positive stiffness. The maximum lateral strain measured before rupture was approximately 0.01. The actual rupture strain was not measured, because the rupturing did not take place near a strain gauge. The ratio between the lateral strain and the axial strain was very small at low levels of load and increased to about 0.5 close to failure. The weight loss of the expansive concrete specimen subjected to freeze–thaw cycles was recorded at regular intervals and is shown in Fig. 11. The weight loss is within the usual range for normal concrete samples with no air entrainment and subjected to similar freeze–thaw exposures.

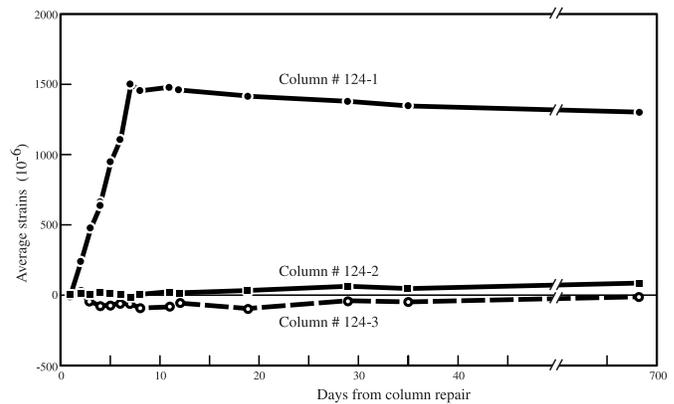
Fig. 12. Lateral strain in glass-fibre-reinforced polymer in repaired columns.

Lateral strain data from the field columns are plotted against time in Fig. 12. As expected, column 124-1 showed substantial expansion, whereas no significant lateral strain was measured in FRP in the other two columns. The maximum expansion in column 124-1, approximately 0.16%, was observed 10 d after grouting and represents about 10% of the GFRP rupture strain. Lateral GFRP strain in all columns remained fairly constant for about 2 years, indicating stable expansive cement behaviour and no significant creep of the GFRP. Recording of strain data was terminated about 2 years after repair.

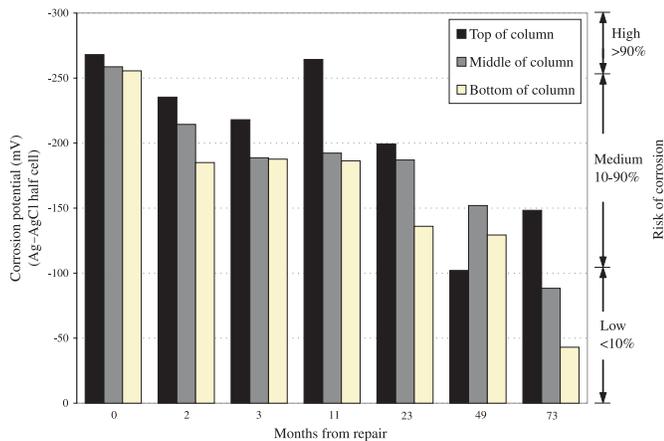
Fig. 13. Average corrosion activity in repaired columns.

clearly seen in Fig. 13, which shows the average corrosion potential for three columns at different locations along their height. The only anomaly is the reading at 11 months at the top of the columns, which may have been caused by local effects, such as wetness at that location. It can be concluded that GFRP wraps protected the columns from adverse environmental effects, thus starving the corrosion of its essential ingredients and resulting in reduced corrosion activity.
