# Accelerated corrosion and repair of reinforced concrete columns using carbon fibre reinforced polymer sheets

C. Lee, J.F. Bonacci, M.D.A. Thomas, M. Maalej, S. Khajehpour, N. Hearn, S. Pantazopoulou, and S. Sheikh

**Abstract:** An experimental study on the simulation of corrosion in large-scale reinforced concrete columns and their repair using carbon fibre reinforced polymer (CFRP) sheets is presented. Seven columns were subjected to an accelerated corrosion regime, wrapped using CFRP sheets, then tested to structural failure and (or) subjected to further post-repair accelerated corrosion, monitoring, and testing. Accelerated corrosion was achieved by adding sodium chloride to the mixing water, applying a current to the reinforcement cage, and subjecting the specimens to cyclic wetting and drying. Results showed that the CFRP repair greatly improved the strength of the repaired member and retarded the rate of post-repair corrosion. Moreover, subjecting the repaired column to extensive, post-repair corrosion resulted in no loss of strength or stiffness and only a slight reduction in the ductility of the repaired member.

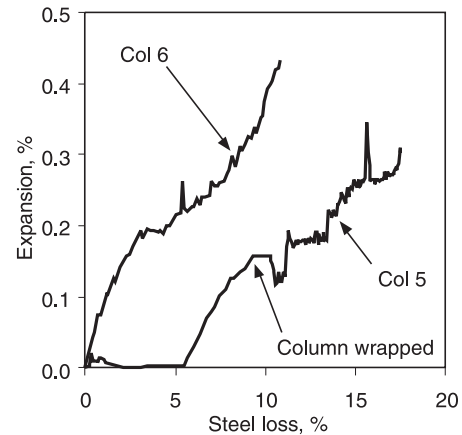
Dramatic increases in the rate of expansion per unit of steel loss were experienced by all specimens after the changes discussed above were implemented (see COL5 in Fig. 5). The lack of damage indicated in the early part of the accelerated corrosion for COL5 was likely due to the lack of oxygen resulting from the maintenance of constant relative humidity. Subsequent series of columns (as represented by COLS6 in Fig. 5) were exposed to this modified accelerated corrosion regime from the onset and similar high rates of damage were observed from the beginning of the accelerated corrosion testing period.

**Fig. 5.** Effect of changes to the accelerated corrosion regime on the rate of expansion.

Although an effort was made to implement changes to the regime in such a manner that the effects of each change could be assessed independently, this was not always possible. Therefore, it is not possible to determine with certainty which change triggered the acceleration of damage. A cursory examination of the corrosion current and expansion data suggests that the increase in voltage had the greatest effect on accelerating circumferential expansion.

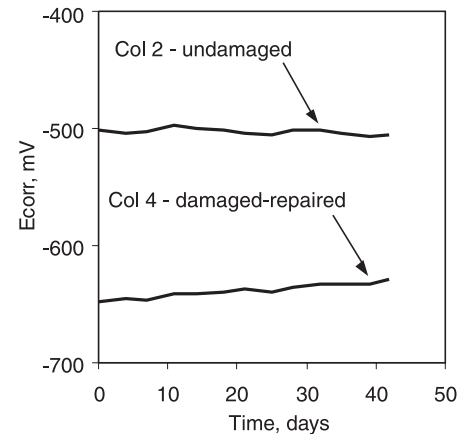
Figure 7 shows the half-cell potentials for the reinforcing bars in COL2 and COL4 measured against a copper – copper sulphate standard half-cell during the last 3 weeks of the testing period. Both potentials indicate an active state of corrosion in the reinforcing bars. It is interesting that the steel in COL4 (the repaired column) has a higher negative potential indicating a greater risk of corrosion. This may be due to a higher chloride content at the steel in COL4, owing to the migration of chloride ions to the anode during the accelerated corrosion process. Despite the higher potential of the steel in COL4, the results of linear polarization tests shown in Fig. 8 indicate a significantly lower corrosion current,  $I_{corr}$ , in this specimen. Indeed, the value of  $I_{corr}$  measured in COL4 was about one half of the current determined for COL2. No attempt was made to determine the corrosion current density because of uncertainty in establishing the anodic area.

**Fig. 7.** Effect of repair on corrosion potentials.
