### Seismic Upgrade with Carbon Fiber-Reinforced Polymer of **Columns Containing Lap-Spliced Reinforcing Bars**

by Kumar K. Ghosh and Shamim A. Sheikh

Keywords: columns; confinement; ductility; lap splice; rehabilitation.

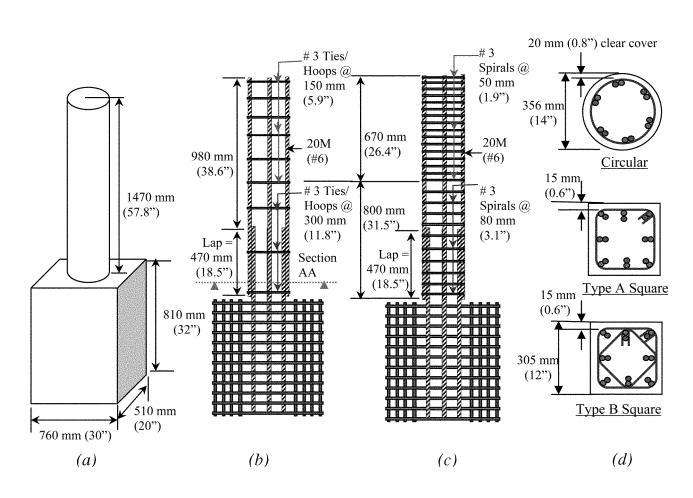
Fig. 1—Specimen details: (a) dimensional details; (b) reinforcement details of square and Type A circular columns; (c) reinforcement details of Type B circular columns; and (d) sectional details.

The circular columns were reinforced with six 20M and the square columns with eight 20M longitudinal bars that were lap spliced in the column for a length of 470 mm (18.5 in.) from the stub-column interface (Fig. 1). Two configurations of transverse reinforcement, Types A and B, were used. For the circular specimens, Type A columns were detailed with U.S. No. 3 hoops at 300 mm (11.8 in.) spacing while Type B columns consisted of U.S. No. 3 spirals at 80 mm (3.1 in.). For the square specimens, Type A columns were reinforced with only one set of U.S. No. 3 ties at 300 mm (11.8 in.), such that only the corner bars were held by corners of the ties. The Type B square specimens were reinforced with two sets of U.S. No. 3 ties at 300 mm (11.8 in.) so that every longitudinal bar was laterally supported by tie corners. To ensure that failure of the specimens occurs at the potential plastic hinge region, beyond a distance of approximately 600 mm (23.6 in.) from the stub-column interface, the spacing of the transverse steel was reduced to approximately half the specified spacing in the test zone as shown in Fig. 1.

The reinforcement for the stub consisted of 10M horizontal and vertical stirrups at 64 mm (2.5 in.) spacing. Additional 10M bars with 135-degree hooks were added at two sides to increase stub stiffness. The reinforcement details are illustrated in Fig. 1.

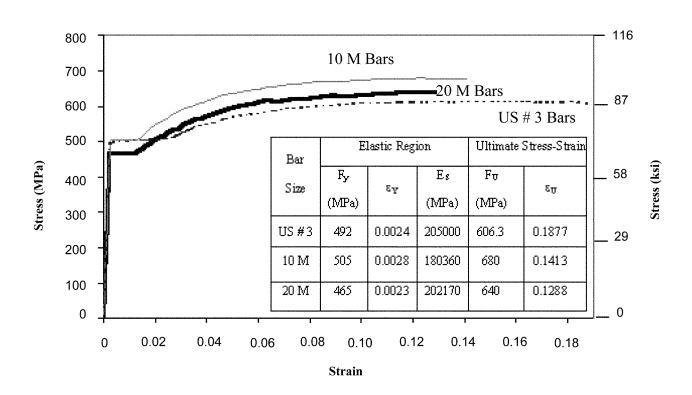
Fig. 2—Stress-strain behavior of steel.

*Reinforcing steel*—Three types of deformed steel bars were used to construct the reinforcing cages of the specimens. Grade 400, 20M (area =  $0.465 \text{ in.}^2$  [300 mm<sup>2</sup>]) bars and Grade 60 U.S. No. 3 bars were used for the longitudinal and the transverse reinforcement in the columns, respectively. Grade 400, 10M (area =  $0.155 \text{ in.}^2$  [100 mm<sup>2</sup>]) bars were used to construct the stub reinforcing cages. The stressstrain curves of steel bars along with the yield and ultimate stress and strain values are presented in Fig. 2. The columns were detailed as per the provisions of the ACI 318-56<sup>16</sup> and ACI 318-63<sup>17</sup> codes.

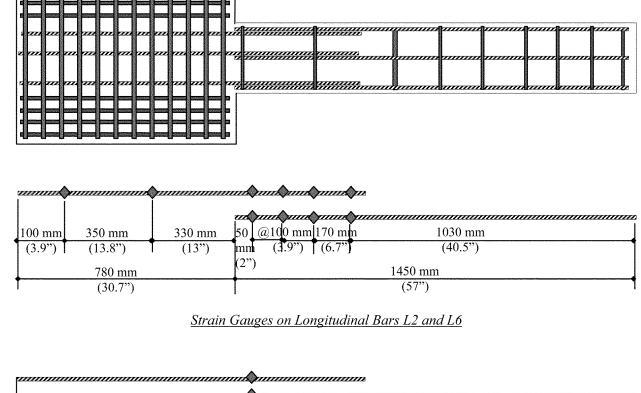
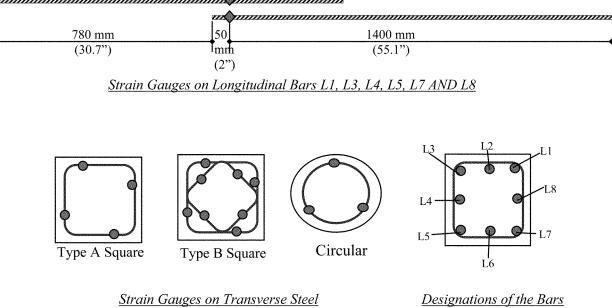
Fig. 3—Locations of strain gauges on longitudinal and transverse reinforcement.

*Instrumentation*—The longitudinal and transverse reinforcing bars of the specimens were instrumented extensively to determine the steel strains at various locations (Fig. 3). In the B-type circular columns, the first three rings of the spirals were instrumented, while in the other specimens the first two

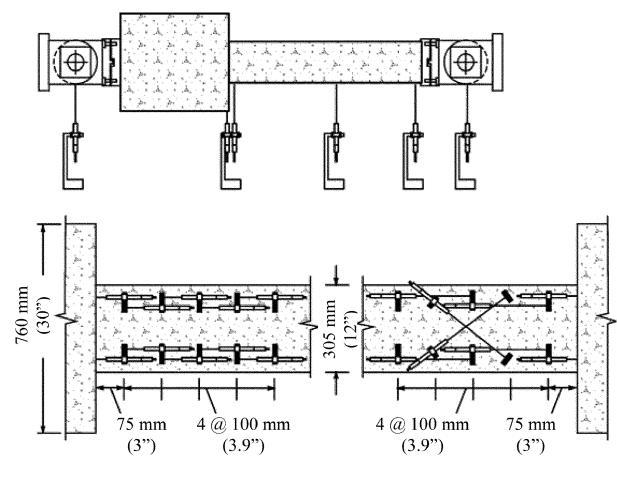
Fig. 4—LVDT arrangements.

A total of 18 linear variable differential transducers (LVDTs), 10 on one side and eight on the opposite side, were mounted to the rods embedded in the columns to measure the deformations of the concrete core in the test region of the specimens (Fig. 4). The gauge lengths for these LVDTs varied from 55 to 110 mm (2.2 to 4.3 in.) and covered a length of 550 mm (21.6 in.) from the face of the stub. Transverse displacements were measured by LVDTs placed at six locations along the lengths of the specimens.

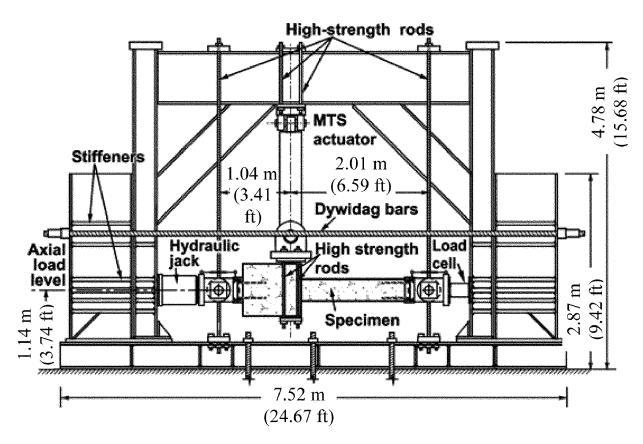
Fig. 5—Testing frame.

All the columns were tested under constant axial load and reversed cyclic displacement excursions in a test frame (Fig. 5). Axial load was applied first using a 4450 kN (1000 kips) capacity hydraulic jack through hinges at the ends of the specimens allowing in-plane end rotations. The reversed cyclic lateral load was then applied through a servocontrolled actuator having 1000 kN (220 kips) load capacity and ±152 mm (6 in.) stroke capacity. Displacement control mode of the actuator was used to apply the predetermined displacement history (Fig. 6) at the interface in which the specimen was subjected to a displacement of 0.75  $\Delta_1$  for the first cycle followed by two cycles each of  $\Delta_1$ ,  $2\Delta_1$ ,

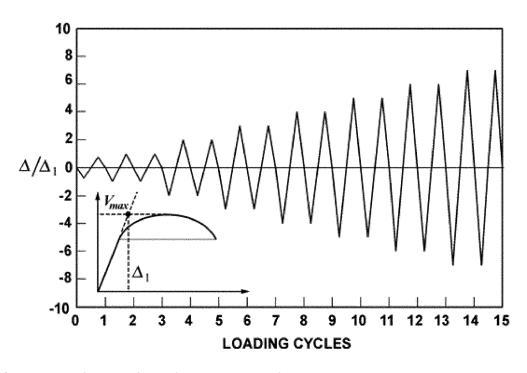
Fig. 6—Loading displacement history.

$3\Delta_1$ ...until the specimen was unable to maintain the applied axial load. Deflection  $\Delta_1$  (also defined in Fig. 6) represents the yield displacement at interface and was calculated from the theoretical sectional response of the unconfined specimen. All the data were collected by a high-speed data acquisition system.

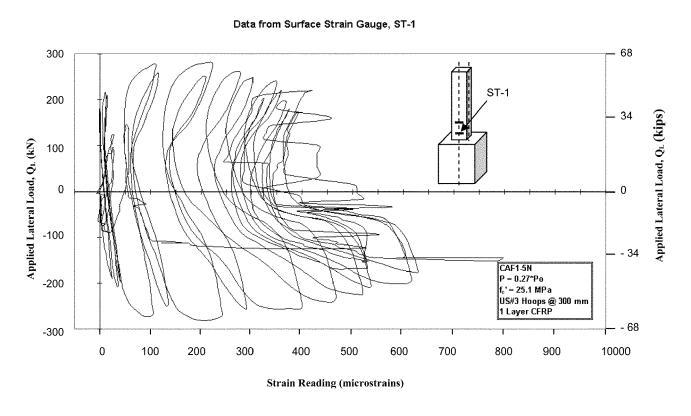
Fig. 7—Variation of fiber-reinforced concrete with load in Specimen CAF1-5N.

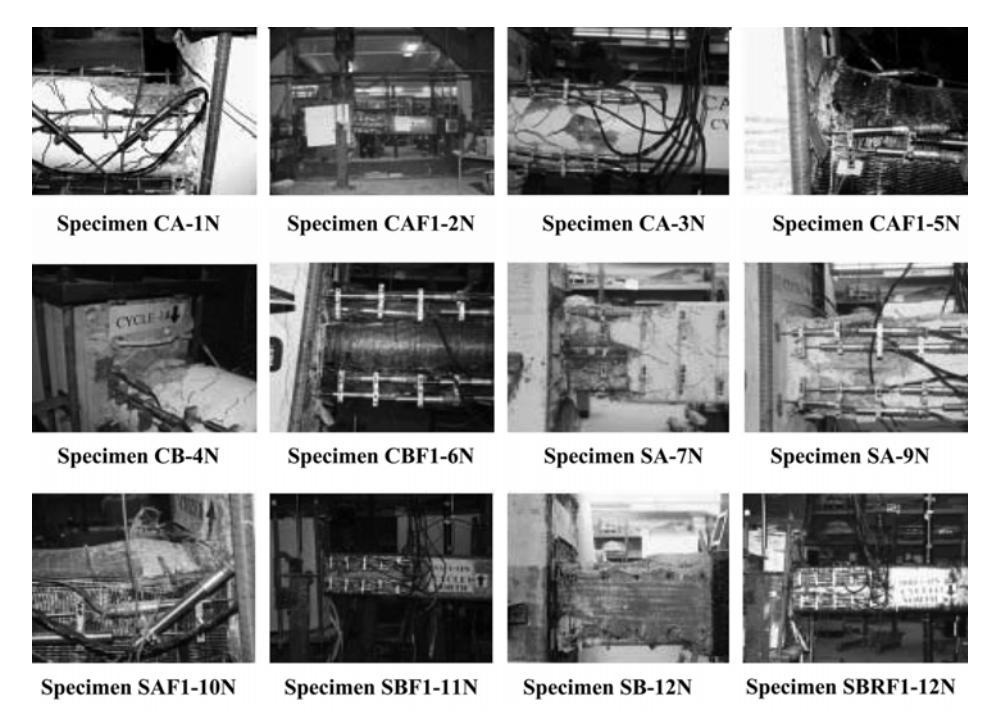
*Fig.* 8—*Specimens after testing.*

Specimen SAFI-8N ( $P = 0.05P_o$ ) suffered premature failure at the end of the fourth cycle, which resulted in termination of the test in the fifth cycle. Considerable crushing and diagonal cracks were observed at the end of the stub, where steel plates were used to attach the specimen with the test apparatus. Poorly compacted concrete, causing pullout of the anchor bolts, seemed to be the reason for this unexpected failure. All the specimens except SAFI-8N, at the end of the tests, are shown in Fig. 8.

The extent of damage prior to the repair is shown in Fig. 8. The ductility factor  $\mu_{\Delta 80}$  and work index  $W_{80}$  of the retrofitted damaged column, SBRF1-12N were approximately 34 and 167% higher compared with the original column, SB-12N. The repaired column SBRF1-12N, however, achieved only 63% of the displacement ductility and 30% of the work damage indicator value of a similar Specimen SBF1-11N that was strengthened before any prior damage. It should be noted that Specimen SB-12N was damaged more than anticipated, and it was unable to recover its original load and moment carrying capacity. In spite of the extensive damage, retrofitting with a single layer of CFRP was successful in obtaining a significantly more ductile column behavior. The effectiveness of CFRP in retrofitting damaged columns obviously depends on the extent of the sustained damage.

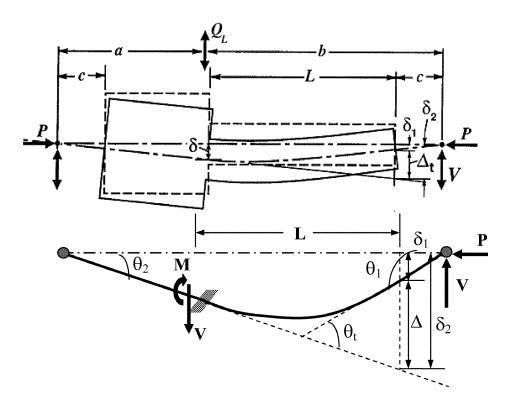
Fig. 9—Idealization of test specimen.

Figure 9 illustrates the idealized test specimen. Responses of the specimens can be presented graphically in the form of shear force V versus tip deflection  $\Delta_t$  and moment at interface M versus total differential rotation  $\theta_t$  plots. The shear force V was determined from the applied lateral load  $Q_L$ . The

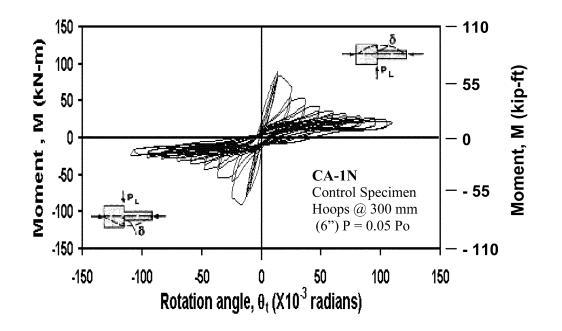
Fig. 10-Moment-rotation response of Specimen CA-1N.

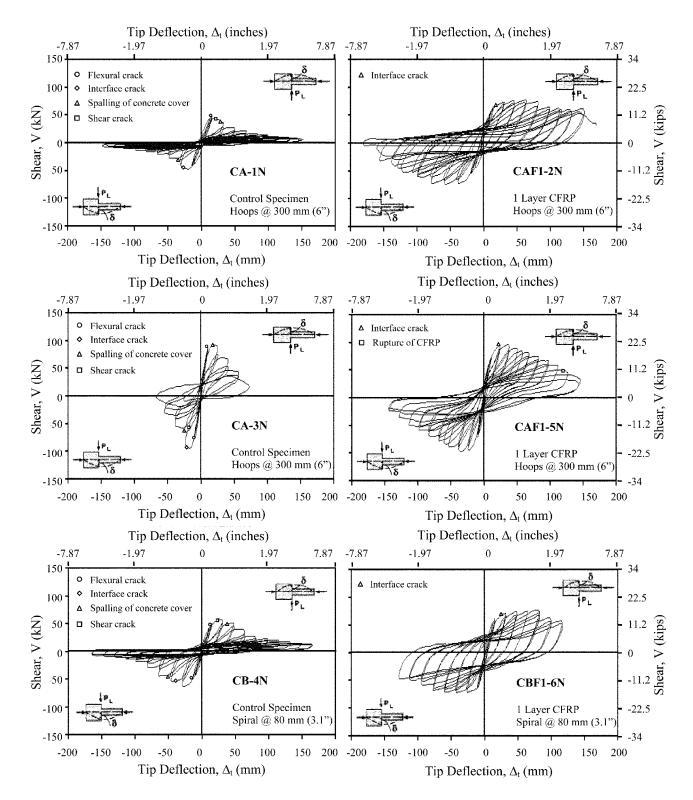
Fig. 11—Shear (V)—tip deflection ( $\Delta_t$ ) responses of circular columns (Group I).

It is evident from Table 1 and Fig. 11 and 12 that there were considerable improvements in the ductility factors and work indexes of the circular columns containing larger amount of transverse steel in more closely spaced spirals. The better confinement of concrete produced by the uniform clamping pressure applied by the transverse reinforcement around the spliced longitudinal reinforcement helped to delay the formation of internal splitting cracks along the splice length, thus increasing the splice/bond strength of the longitudinal bars and resulting in improved ductility. The  $\mu_{\Delta 80}$  and  $W_{80}$  values for CB-4N were found to be 1.6 and 2.0 times the corresponding values for CA-1N. For the retrofitted specimens, the  $\mu_{\Delta 80}$  and  $W_{80}$  values of CBF1-6N increased 1.2 and 1.7 times those for CAF1-2N. The FRP wraps, however, were found to provide more effective confinement as compared with the presence of closely spaced spirals. This can be concluded by comparing the performance of Specimens CAF1-2N (specimen strengthened with FRP wraps) and CB-4N (specimen with closely spaced spirals), respectively, with that of control Specimen CA-1N in Table 1. The  $\mu_{\Lambda 80}$ and  $W_{80}$  values for CAF1-2N were found to be 2.97 and 18.2 times the corresponding values for CA-1N while the  $\mu_{\Delta 80}$  and  $W_{80}$  values for CB-4N were found to be 1.6 and 2.0 times the corresponding values for CA-1N. The best performance out of all the specimens was obviously observed in Specimen CBF1-6N with both closely spaced spirals and FRP strengthening.

As is evident from Fig. 11 and 12, all the control specimens exhibited poor hysteretic response due to premature splice failure resulting in low ductility and energy dissipation. Retrofitting of the columns with FRP resulted in more stable response with less pinching and lower strength and stiffness degradation rates. The improvements were found to be much larger in circular columns than in square ones due to higher efficiency of CFRP wraps in circular configuration. Whereas the work index increased by up to approximately 20 times due to retrofitting, increase in the moment capacity ranged from 7% (CAF1-5N) to 61% (CAF1-2N) in the columns tested.

It is also evident from Fig. 11 and 12 that the control columns tested under high axial load levels underwent rapid degradation of strength and stiffness and failed at much lower levels of displacements excursions than the columns tested at low axial loads. It is to be noted that high axial load improves the performance of the splice by reducing the tensile force produced by flexure during cyclic lateral load excursions. As a result, the splice-deficient columns tested at high axial load levels may be expected to have a better performance. The poor confinement of the core concrete and buckling of the longitudinal bars, however, play a major role in causing the poor performance of columns under high axial load. The presence of FRP improves this behavior substantially resulting in a less severe effect of higher axial load on the retrofitted columns. It is also to be noted that for the columns strengthened with the CFRP jackets, CAF1-5N and SAF1-10N, rupture of FRP was observed to result in ultimate failure as the mode of failure of these columns was shifted from slippage to buckling of longitudinal reinforcement.

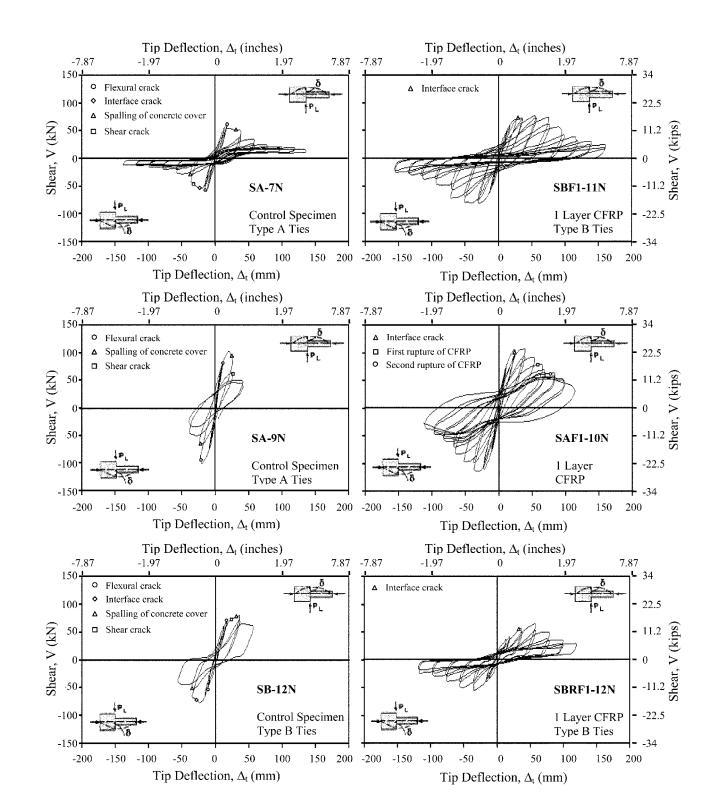
Fig. 12—Shear (V)—tip deflection ( $\Delta_t$ ) responses of circular columns (Group II).

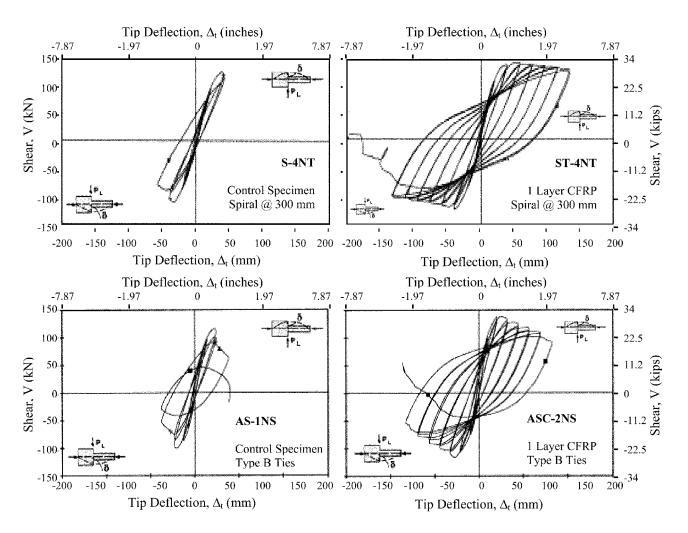
*Fig.* 13—Shear (V)-tip deflection ( $\Delta$ ) responses of columns (Group III and IV) without lap splices.

total moment at interface was the sum of the primary moment produced by the lateral load and the secondary moment caused by the axial load. The deflected shape of the column obtained from the LVDT readings was used to calculate the secondary moment. The differential rotation angle  $\theta_t$  was measured as the angle made by the tangent at the column-stub interface with the tangent drawn at the column tip. The deflection values obtained from the LVDT readings were used to compute the rotation angles. The *M* versus  $\theta_t$  and *V*- $\Delta_t$ responses of Specimen CA-1N are presented in Fig. 10 and 11, respectively. Because the rotation components are derived from the deflection values and the moments are derived from the shear and axial forces, both the V- $\Delta_t$  and M- $\theta_t$  plots follow similar pattern of cyclic excursions as is obvious from a comparison of the two responses for Specimen CA-1N. Thus for the rest of the specimens only the V- $\Delta_t$  plots are presented in Fig. 11 and 12 due to limited space. The *M*-versus- $\theta_t$ responses of all the specimens are available elsewhere.<sup>2</sup> Key events during testing such as appearance of longitudinal flexural cracks along the splice length, diagonal shear cracks, interface cracks between the stub and the column, spalling of the concrete cover, and rupture of the CFRP in the retrofitted columns are marked on the plots. Similar plots from earlier tests<sup>7,8</sup> are shown in Fig. 13.

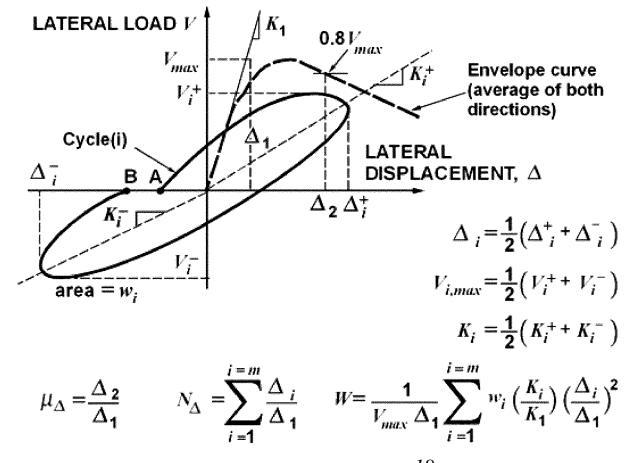
Fig. 14—Member ductility parameters.<sup>18</sup>

proposed by Sheikh and Khoury<sup>18</sup> have been used herein so that comparison can be made with earlier tests.<sup>7,8</sup> These parameters, namely the displacement ductility factor  $\mu_A$ , the cumulative displacement ductility ratio  $N_{\Lambda}$ , and the work damage indicator W have been found to provide a consistent basis for the member behavior and have been defined in Fig. 14. Subscripts T and 80 added to the parameters  $\mu_{\Lambda}$ ,  $N_{\Lambda}$ , and W indicate, respectively, the value of each parameter until the end of the test and until the end of the cycle in which there is 20% reduction in the maximum lateral load. The 20% reduction represents a concrete section with a substantial remaining capacity.<sup>18</sup> Rotation ductility factors can also be similarly defined.<sup>6</sup> Because the rotation angles are derived from the deflection components, a simple relation exists between the displacement and rotation ductility parameters. The performance of the specimens is, therefore, reported herein only in terms of the displacement ductility parameters. The shear and moment capacities, as well as the ductility parameters of the specimens, are presented in Table 1. The test program was designed such that the effects of a variable could be studied by comparing two otherwise similar specimens.
